# *Home Inspection Report*

2008 AnyHouse Lane  
Cincinnati, Ohio 45000

Prepared for: ***Dean Murphy***

Prepared by: ***BEDROCK ENTERPRISES, INC.***  
***4060 Simca Lane***  
***Cincinnati, OH 45211***

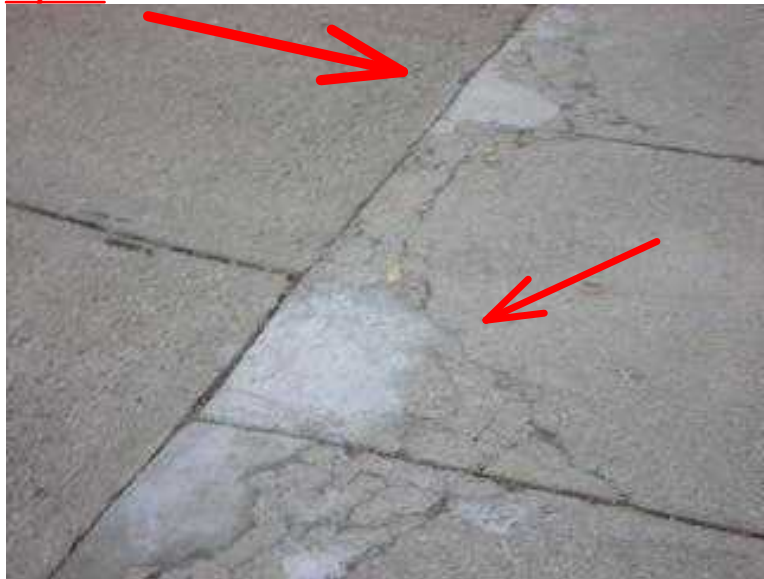
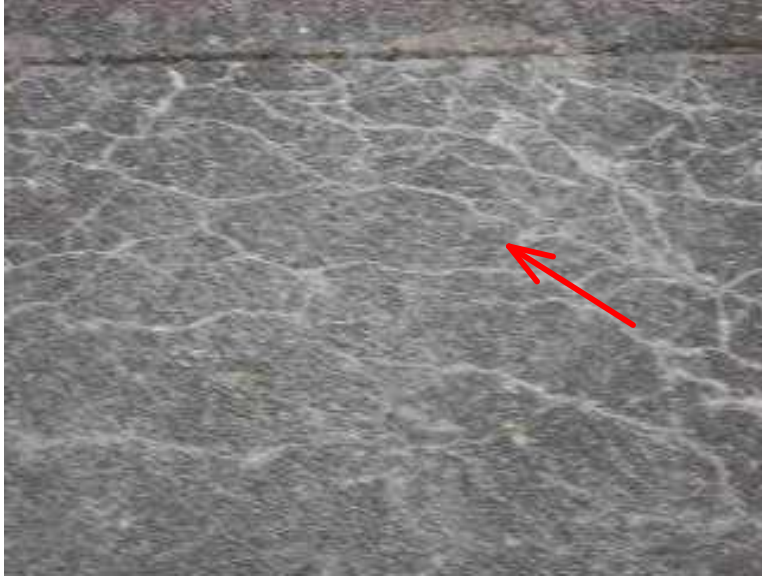
Driveway: original concrete **Some areas of concrete driveway are in need of repair.**

1. Driveway: **original concrete** Some areas of concrete driveway are in need of repair.
2. Vegetation: **Trees and bushes** trim tree branches and vegetation away from house. Branches touching house, may damage roof.

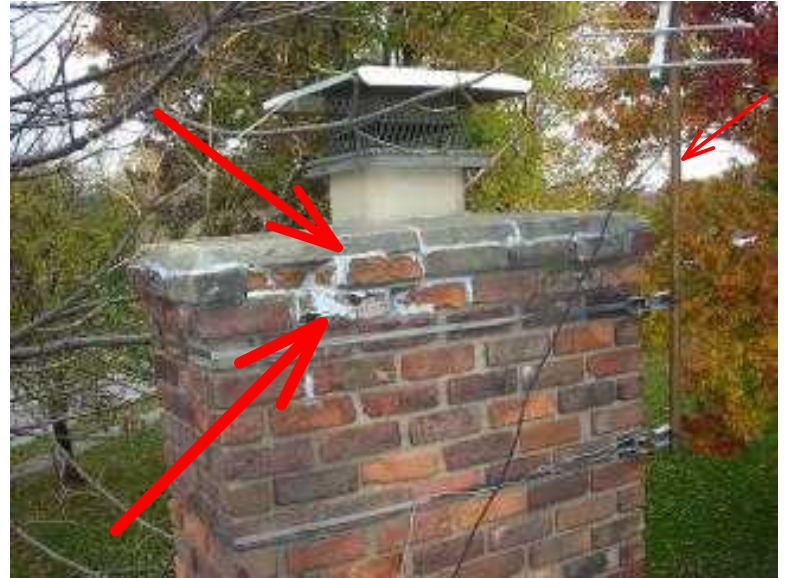
- 5.      Chimney: **Brick Chimney needs tuck pointing and repairs. Some bricks have popped, concrete cap is cracked, tree branches need to be cut back. Recommend remove the TV antenna.**

3. Main Chimney Chimney: **Brick** Chimney needs tuck pointing and repairs. Some bricks have popped, concrete cap is cracked, tree branches need to be cut back. Recommend remove the TV antenna.

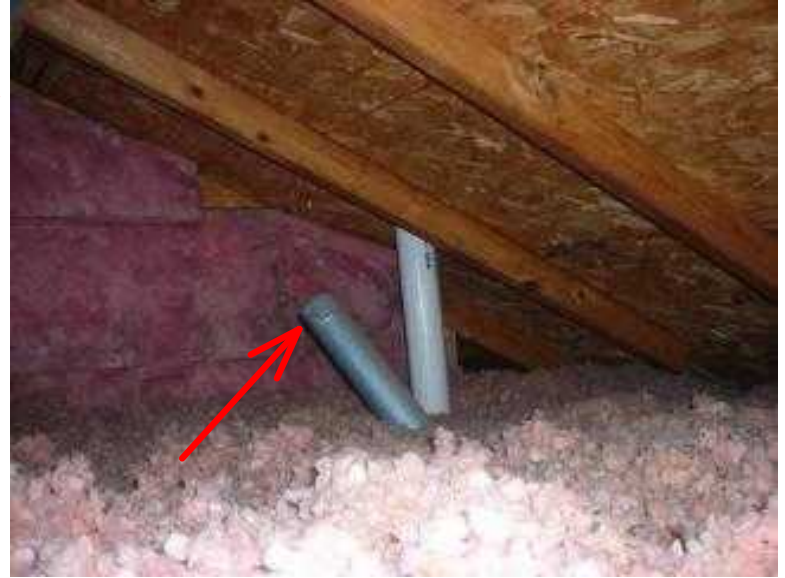
7.      Bathroom Fan Venting: 2nd floor bathroom **Bathroom exhaust fan should be vented outside not into attic**

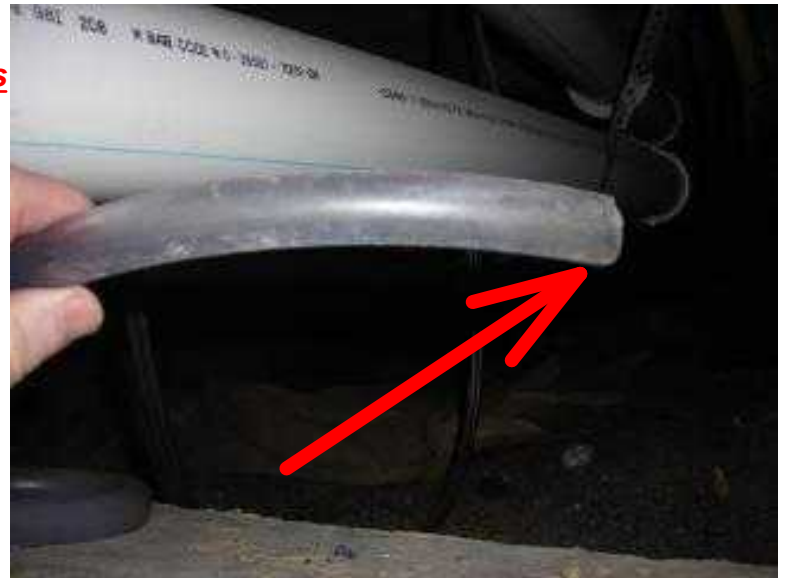
1.      Condensate Removal: **Plastic tubing** **Condensate line drains in crawl space, (safety hazard)**

12. Main AC System Condensate Removal: **Plastic tubing** Condensate line drains in crawl space, (safety hazard)

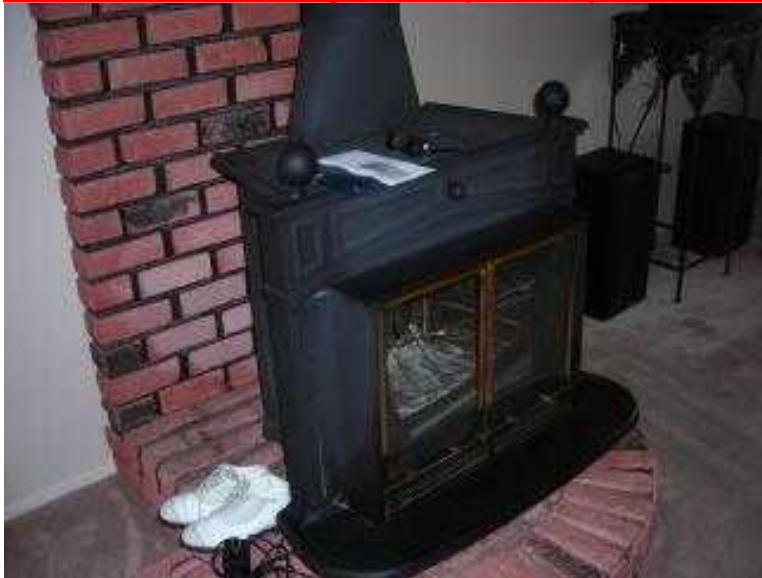
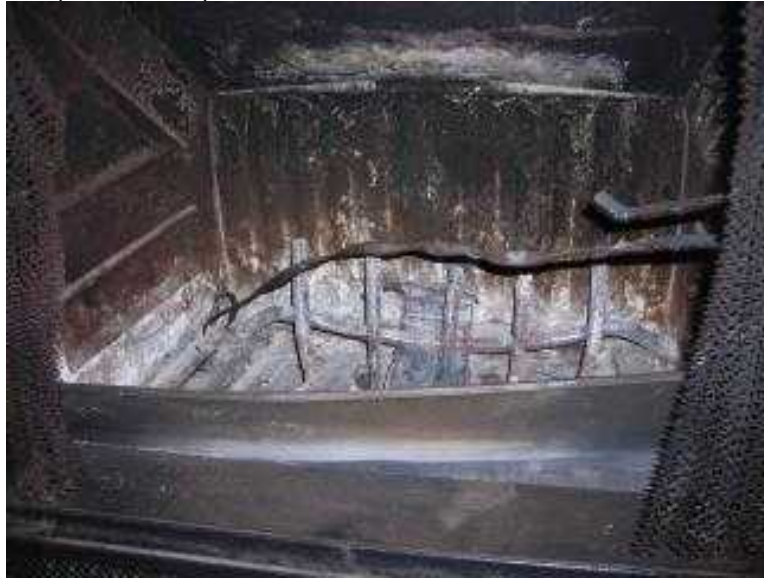
1.      Freestanding Stove: Basement family room Wood Stoves

*-The underwriter may ask for a picture of the stove and its venting system, Recommend cleaning and inspection prior to use*

**Recommend cleaning and inspection prior to use**

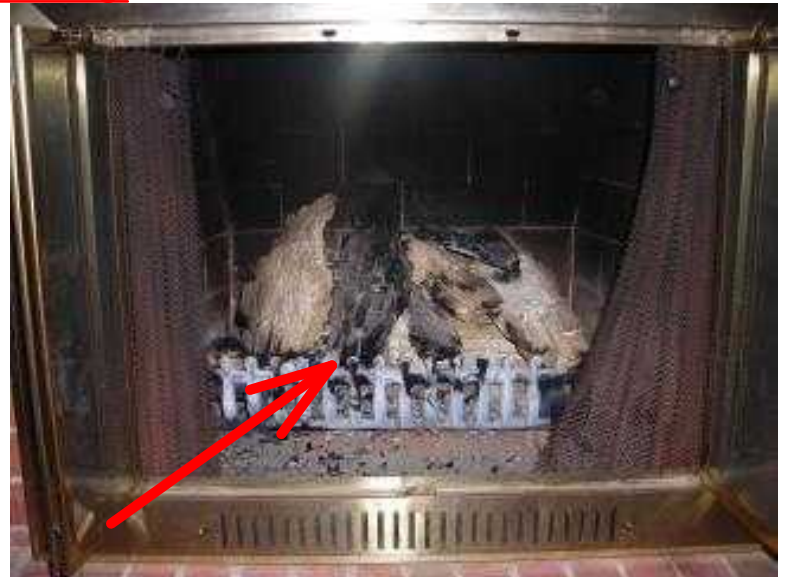
2.      Fireplace Construction: Living room brick fireplace **Heavy creosote build-up may cause a fire inside the chimney. It is recommended that the fireplace and liner be cleaned and serviced before using.**

14. Fireplace Fireplace Construction: **Living room brick fireplace** **Heavy creosote build-up may cause a fire inside the chimney. It is recommended that the fireplace and liner be cleaned and serviced before using.**
15. Fireplace Damper: **Metal** **unable to close, Recommend service**  
Heating System
- 
16. Heating System Heating System Operation: **Extremely dirty, Recommend service and cleaning**  
Laundry Room/Area
- 
17. Basement Laundry Room/Area Dryer Gas Line: **Rigid metal** **The outside dryer vent is covered with vegetation, The vent needs to be above grade/snow levels**

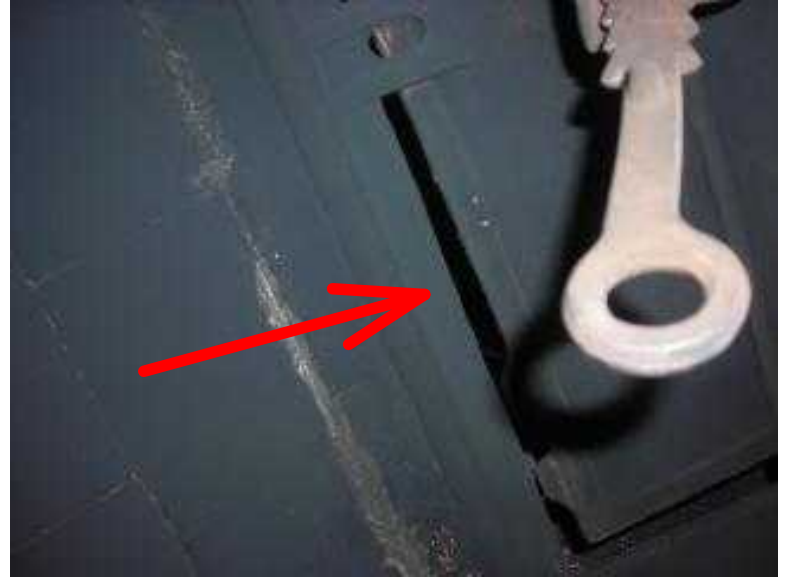
4.  Damper: Metal **unable to close, Recommend service**

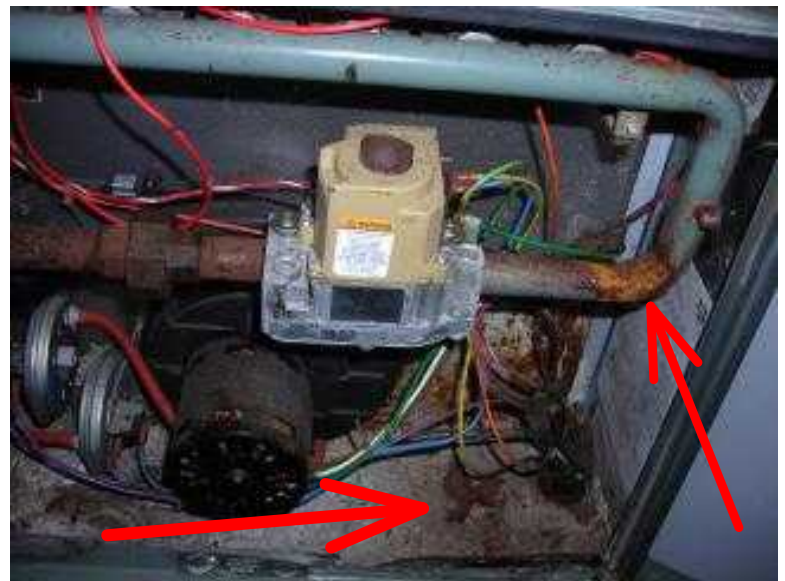
1.  Heating System Operation: **Extremely dirty, Recommend service and cleaning**

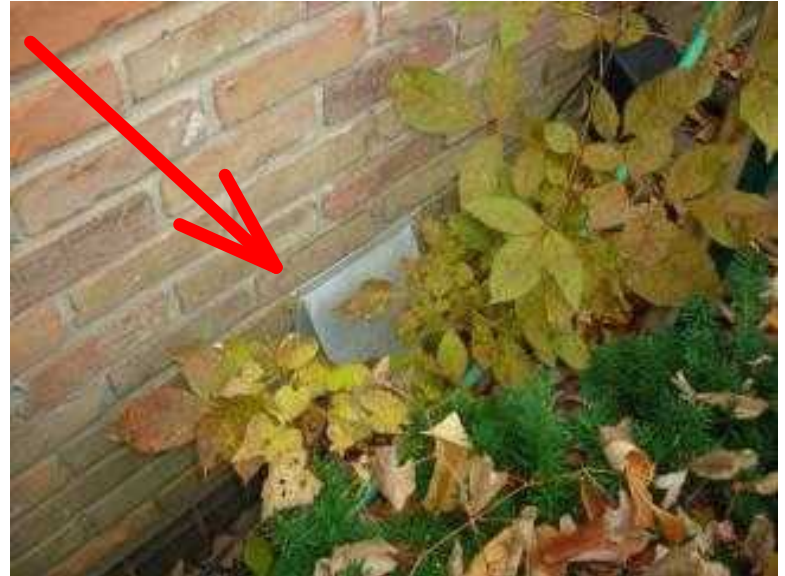
4.	<input type="checkbox"/>	<input type="checkbox"/>	<input type="checkbox"/>	<input type="checkbox"/>	<input type="checkbox"/>	<input checked="" type="checkbox"/>	Dryer Gas Line: <b>Rigid metal</b> - <b><u>The outside dryer vent is covered with vegetation, The vent needs to be above grade/snow levels</u></b>
